# *Environmental Effects of Dredging Technical Notes*

## EQUIPMENT MOBILITY IN CONFINED DREDGED MATERIAL DISPOSAL AREAS; FIELD EVALUATIONS

**PURPOSE:** This technical note describes recently completed equipment evaluations and presents data on mobility of this equipment in confined dredged material containment areas. The equipment evaluation included newly developed four- and six-wheeled low-ground-pressure vehicles. This equipment is typically used to tow a rotary ditching device to create surface trenches to enhance drainage and dewatering of confined dredged material disposal sites.

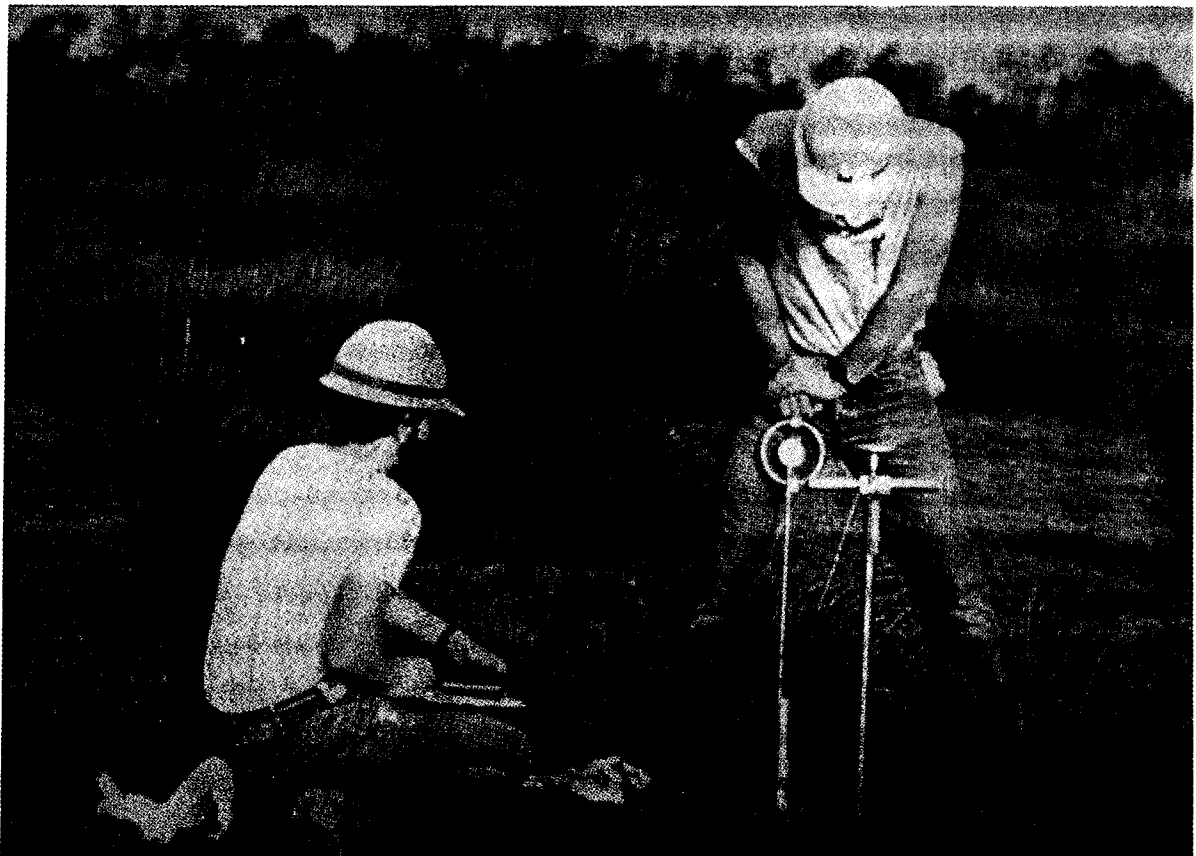
Figure 1. Field soil testing for vehicle mobility determination using the cone penetrometer

During field evaluations, data on the equipment, the equipment operation and performance, and the soils were collected. Pertinent data on the equipment included weight, horsepower, number of tires, and vehicle ground contact pressure. Operation and performance data included speed of movement across the disposal site, linear feet of ditching accomplished per hour, and size of the trench formed (which indicates rate of production in quantity of material removed per hour). Soils data collected included soil strength as recorded by the hand-held cone penetrometer, shown in operation in Figure 1. Results of the field evaluations are discussed in following sections.

To evaluate the potential for equipment mobility in a dredged material disposal site, field data on soil strength must be collected. These data included the cone index (CI) and remolding index (RI), from which the rating

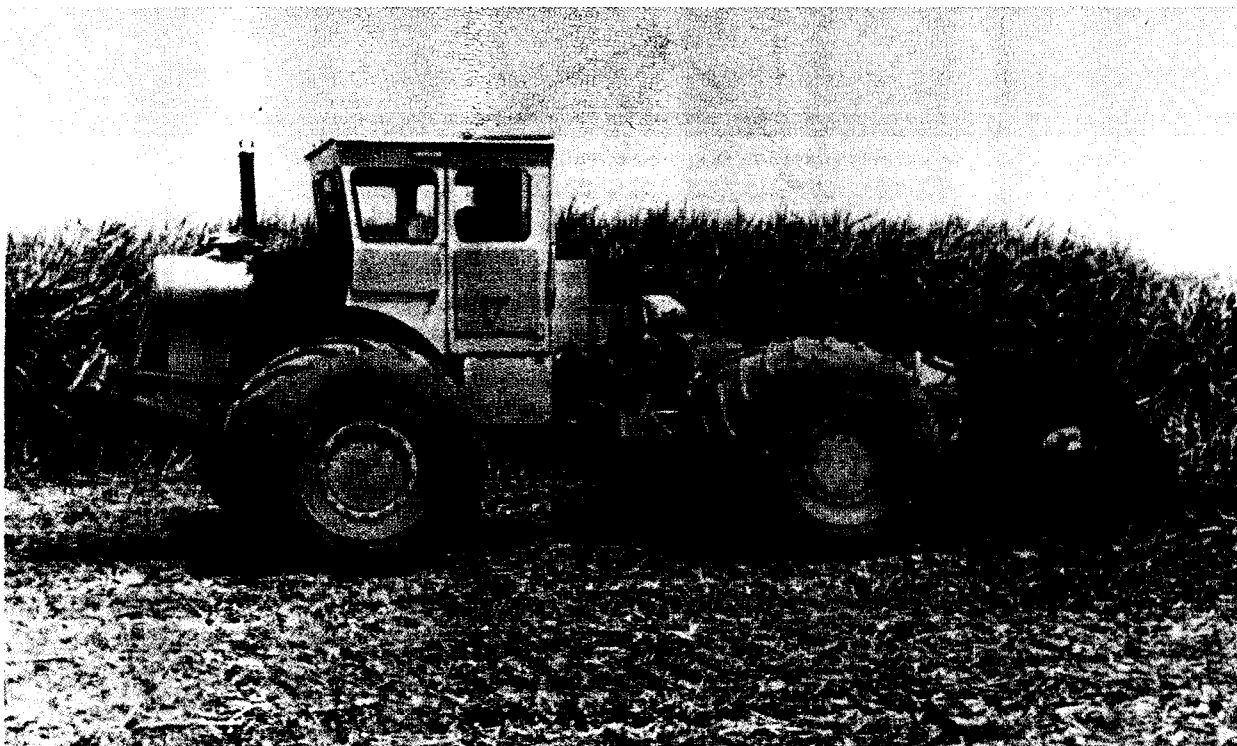
Figure 7. GEMCO vehicle with Dondi ditcher being lowered into position for trenching

The Artificial Island disposal area was the location of field equipment evaluations on June 15-17, 1987. The disposal site, located approximately 60 miles southwest of Philadelphia, is compartmentalized into three separate cells by interior dikes. Figure 6 is a map of the Artificial Island site. Each cell has one weir for water drainage. The dredged material in Artificial Island is predominantly sandy clay. No specific information was available on the thickness of the dredged material deposit in this site. All three cells were covered with a thick growth of *Phragmites* which had to be removed by bulldozing before trenching could begin to prevent entanglement of the vegetation in the rotary ditching device (Figure 7).
